Proper Functioning Condition
And
Amendment 6 Assessments and Ratings
For
Templeton Allotment
Summer 2010

Prepared by: Lisa Sims, Inyo National Forest Aquatic Biologist

March 2011

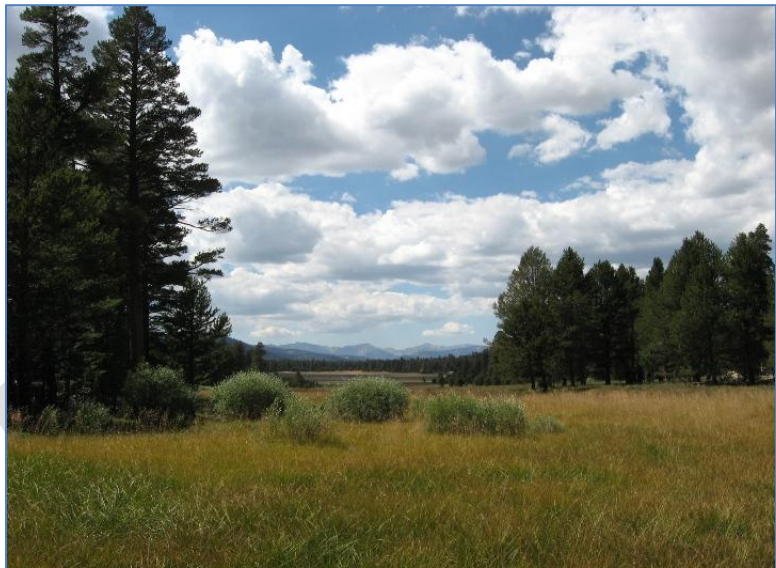
Photo above: Looking down from the eastern arm of Big Dry Meadow.

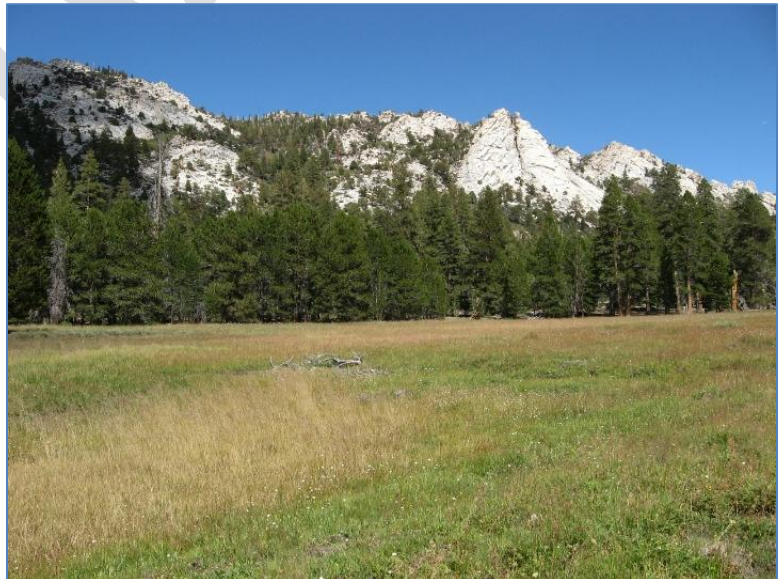
Photo above: Stabilized headcut in the eastern arm of Big Dry Meadow.

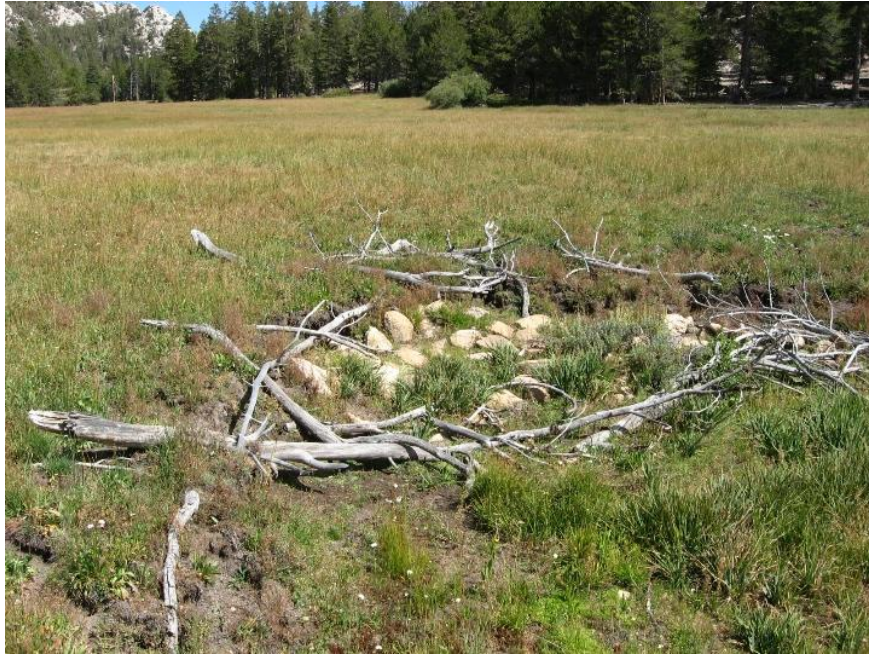
Left: Treated headcut in Big Dry Meadow that has stabilized but exhibits abundant rodent activity at the exposed “rim” of the headcut.

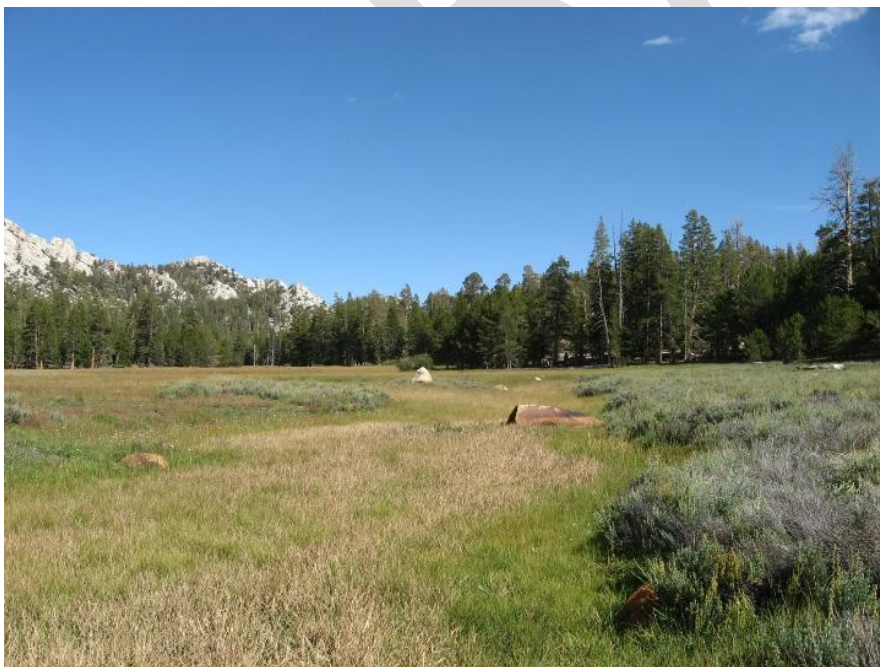
Left: Looking up the new developed floodplain within the east arm of Big Dry Meadow. Treated portions of headcuts are located near the white rock in the mid-photo.

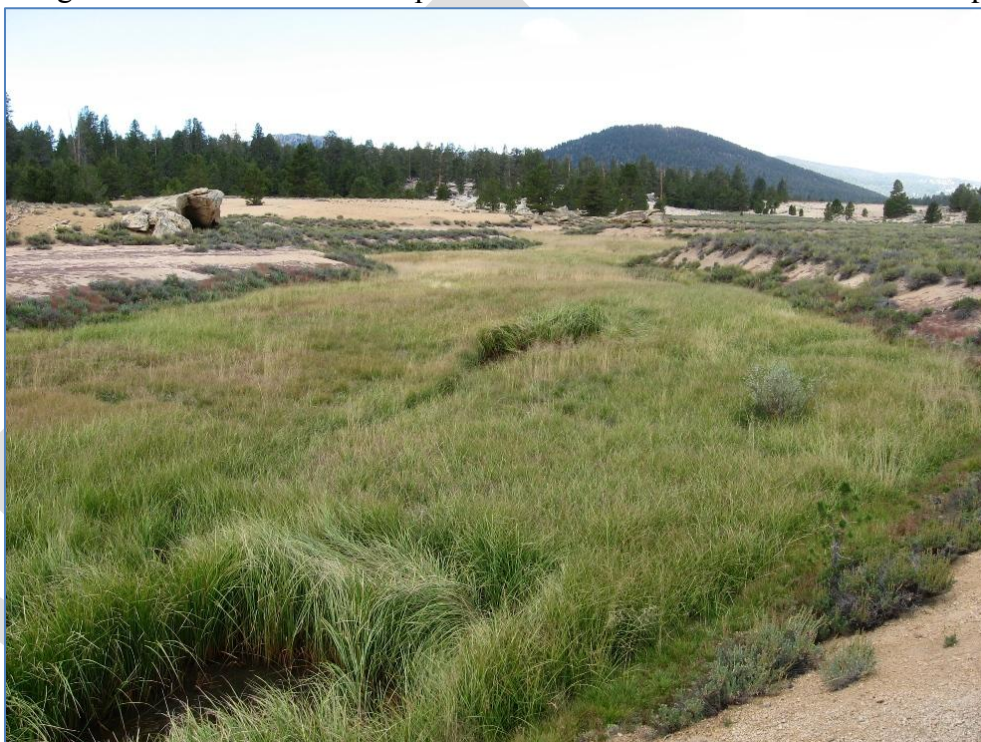
Photo above: Overview of the upper reach of Dry Creek Meadow showing vigorous growth of *Carex utriculata* along the streambanks and within the floodplain.

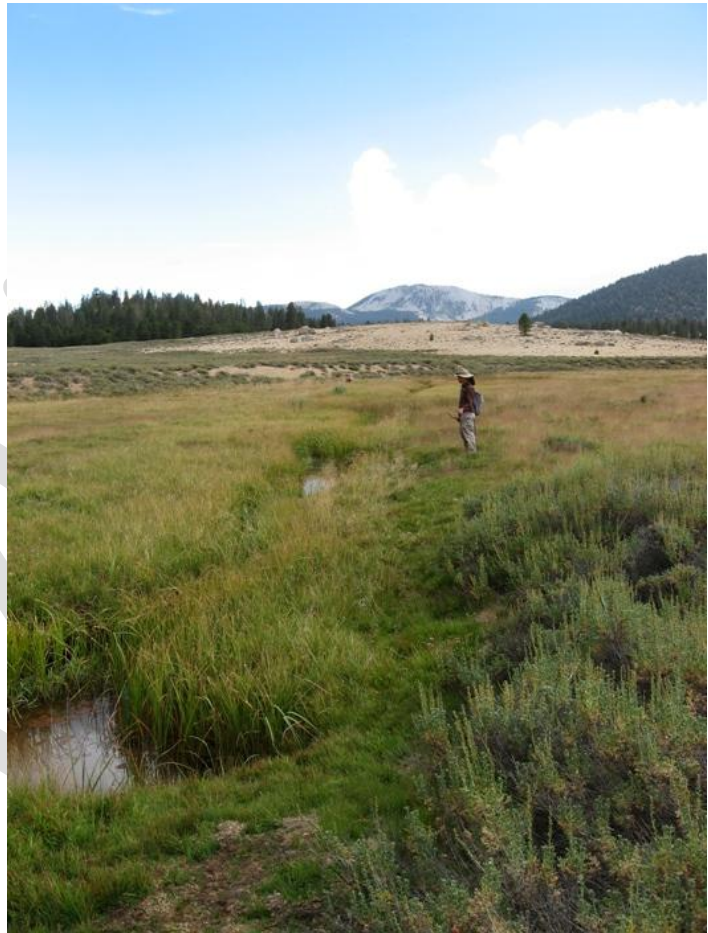
Photo above: Overview of the lower section of Dry Creek Meadow. There was a higher incidence of early and mid-seral plants, mixed with a late seral *Carex* community.

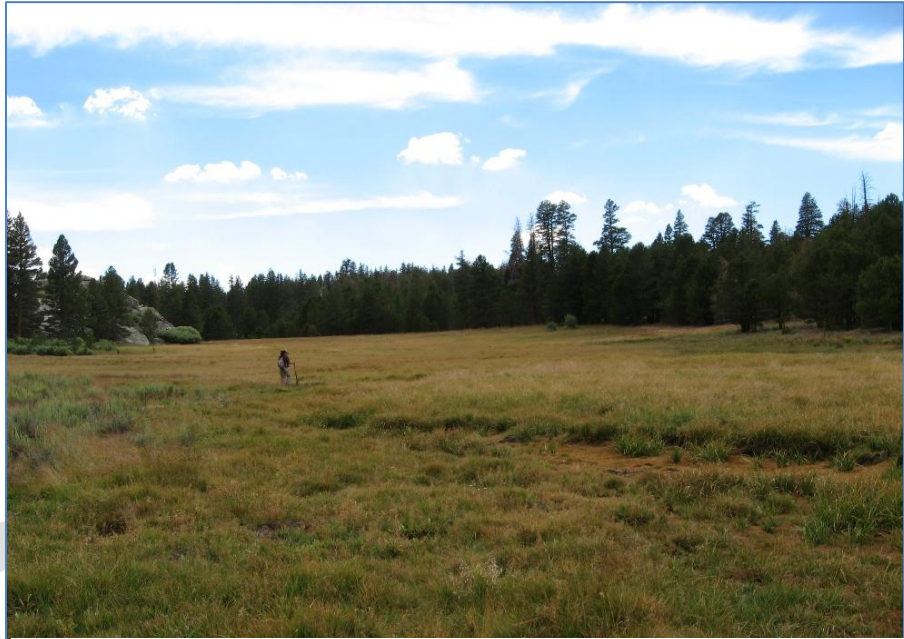
Photo above: Overview of the southwest arm of Grouse Meadow.

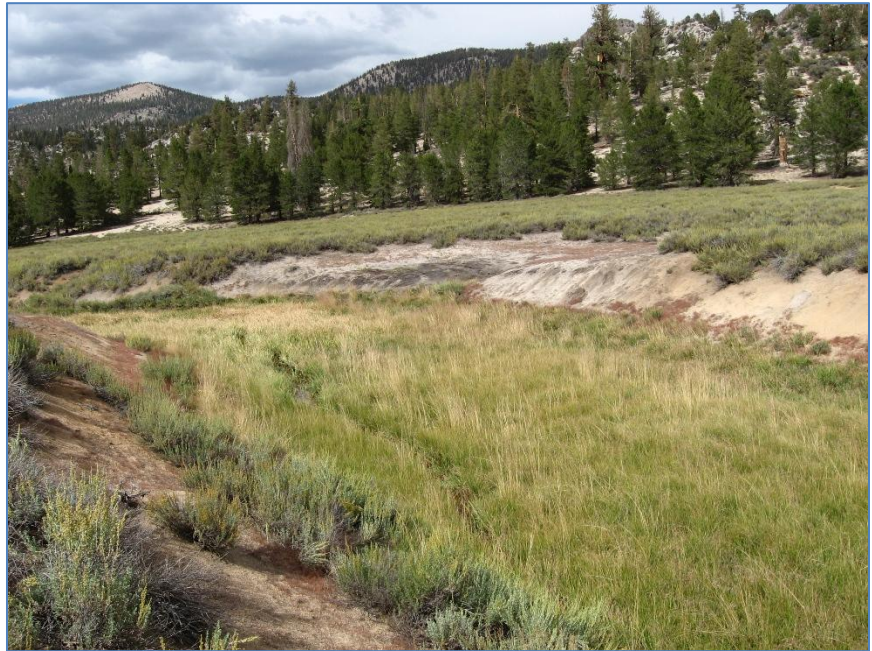
Photo above: Incised channel of Grouse Stringer, showing widening floodplain. In center of photo is an intermittent channel that pre-historically may have been connected to a more productive spring.

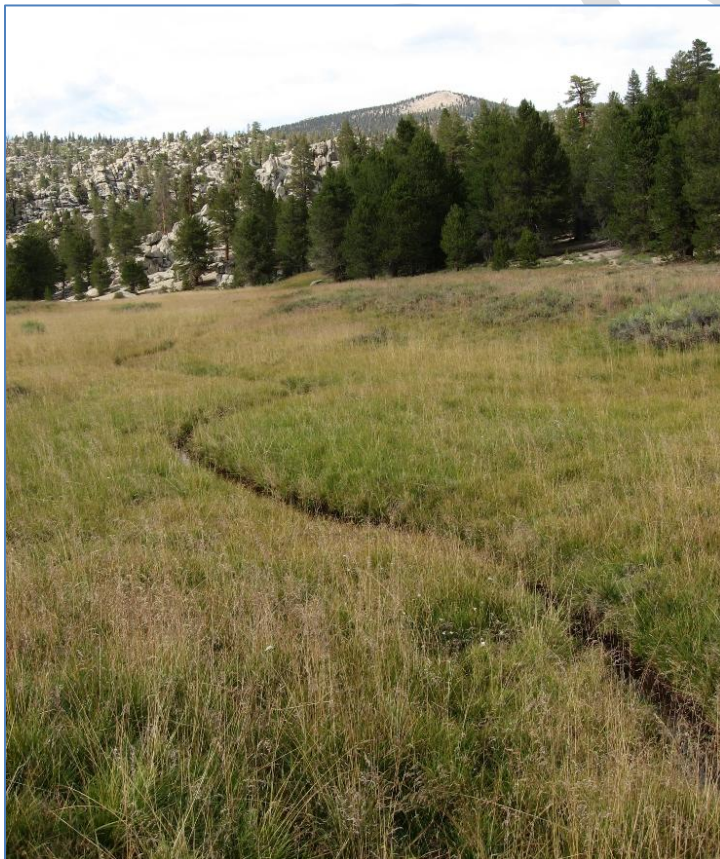
Photo left: Lower reach of Grouse Stringer. This was rated at PFC. *Deschampsia* sp. occurred throughout the meadow but not on streambanks.

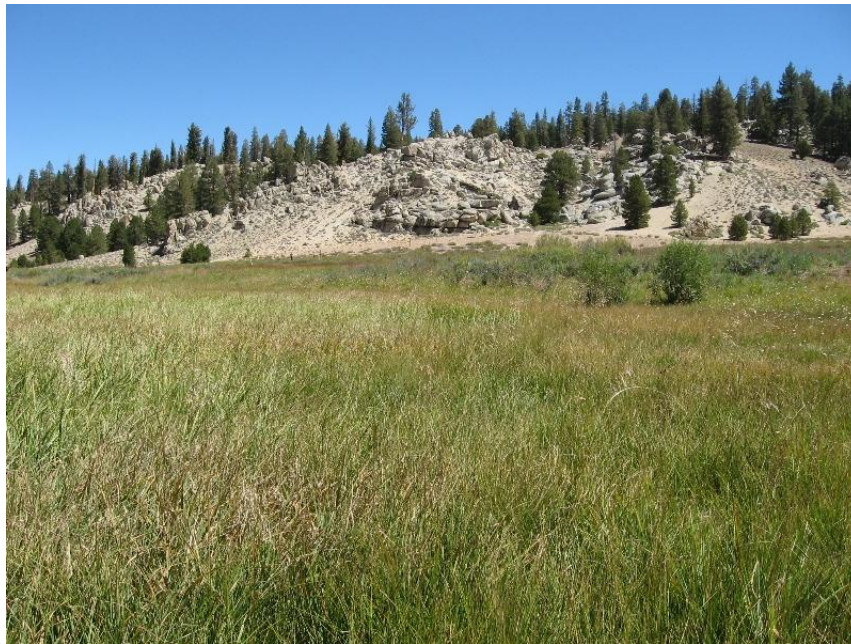
Photo above: Brown Creek and meadow at the lower end of the system.

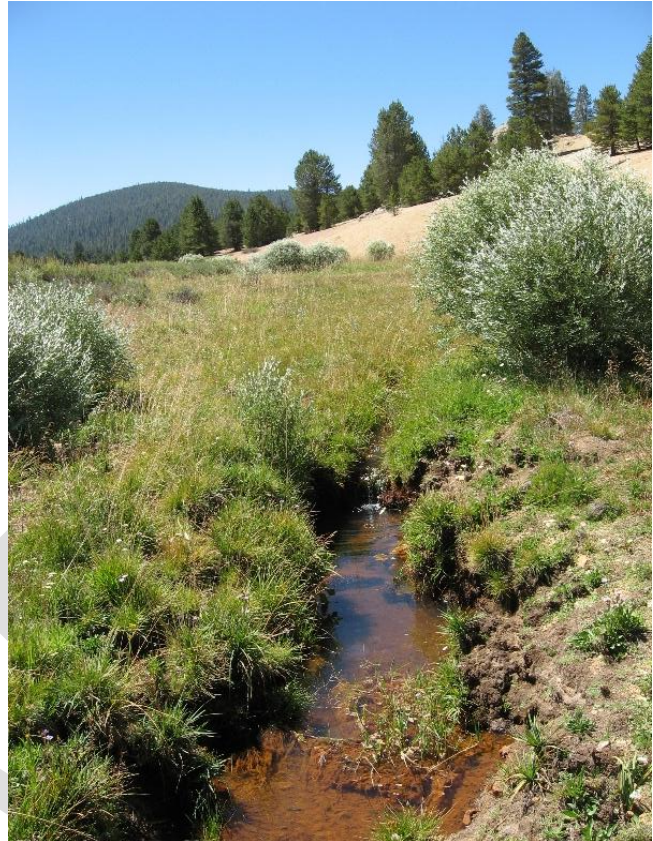
Photo above: One of the active headcuts within Brown Meadow Creek.

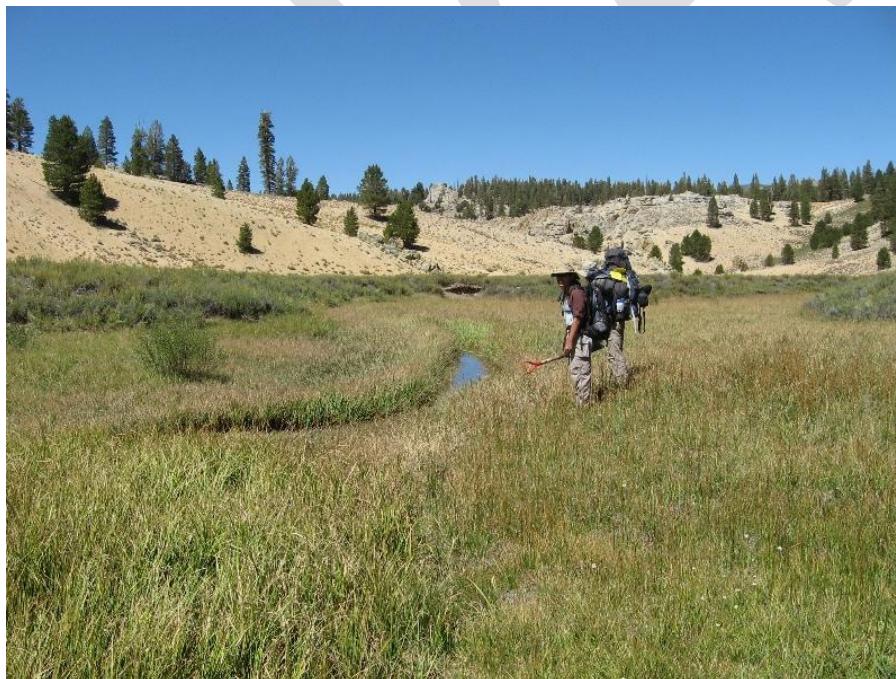
Photo above: The lower section of Brown Meadow, Reach B, looking downstream.

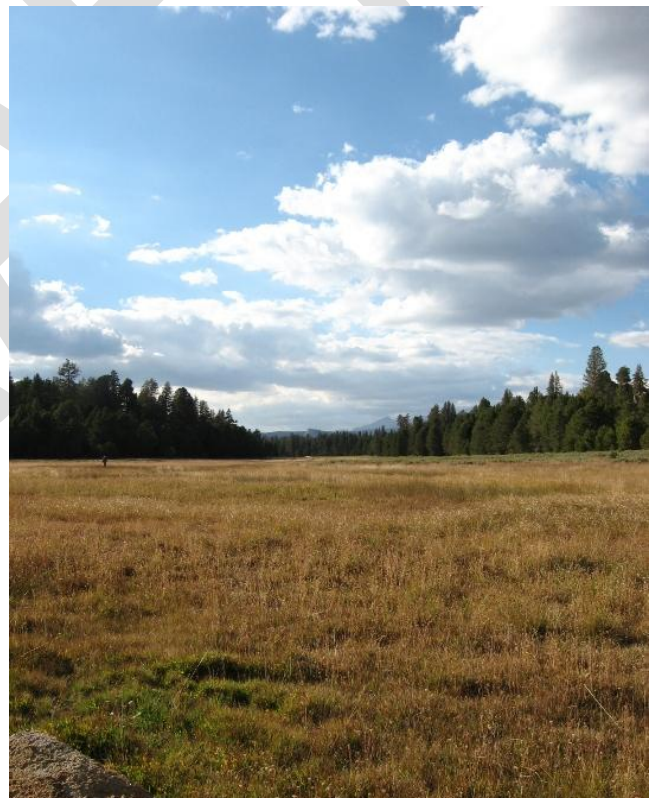
Photo above: Small area of hummocks within Death Canyon Tributary Meadow.

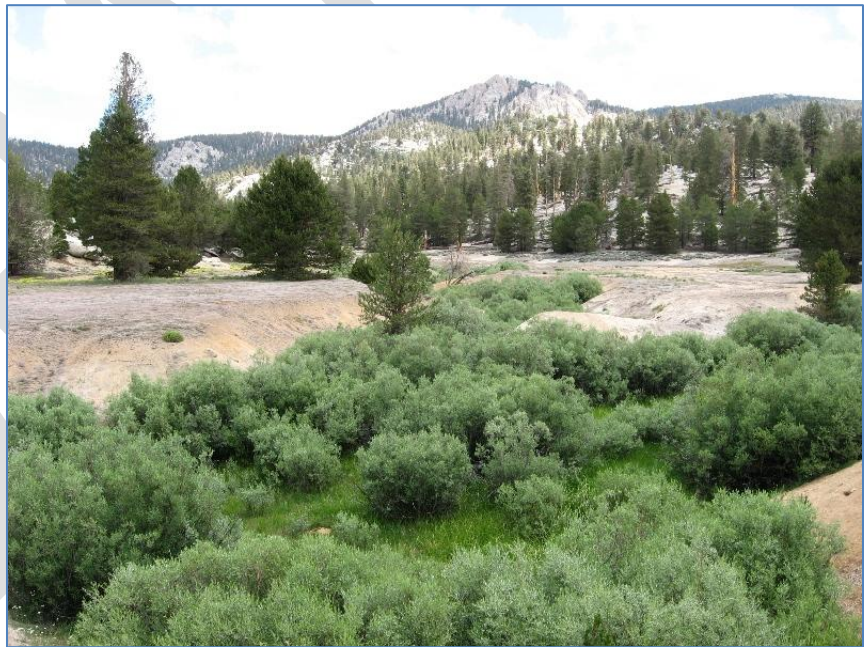
Photo above: Freckles Meadow where two channels converge within the gully.

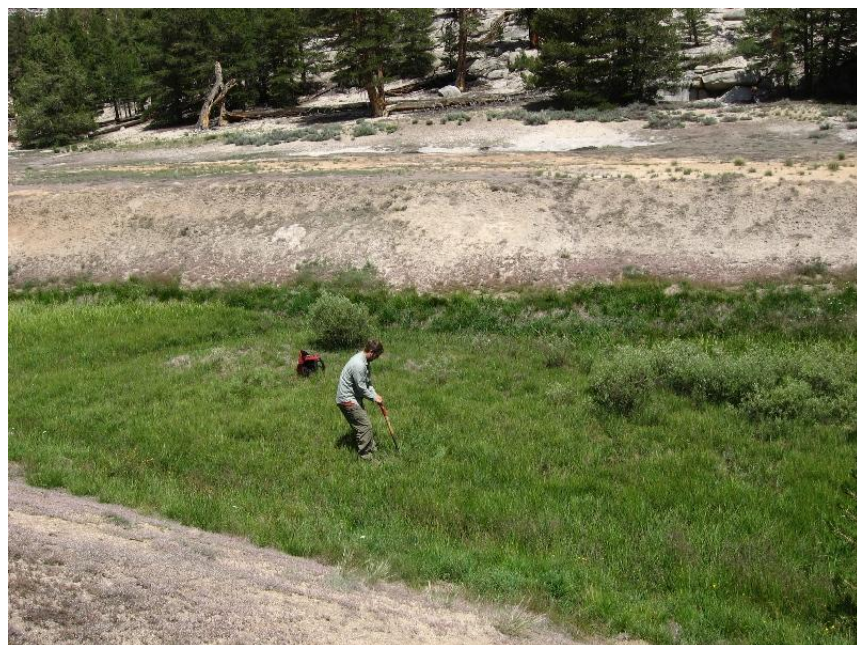
Photo above: Taking a soil sample within the thick *Carex* community within Freckles Meadow floodplain.
